**NATURAL ICING FLIGHT TESTS AND ADDITIONAL SIMULATED  
ICING TESTS OF A UH-1H HELICOPTER INCORPORATING AN  
ELECTROTHERMAL ICE PROTECTION SYSTEM**

R. H. Cotton  
Lockheed-California Company  
P.O. Box 551  
Burbank, Calif. 91520

July 1978

Final Report for Period 17 February 1977 - 15 April 1977

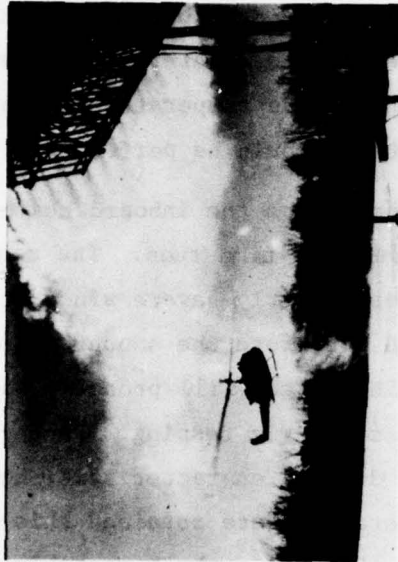
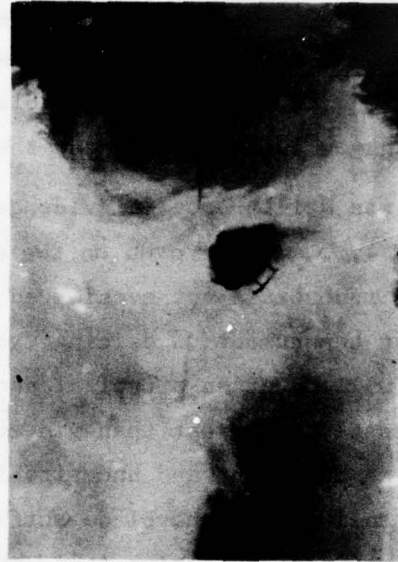
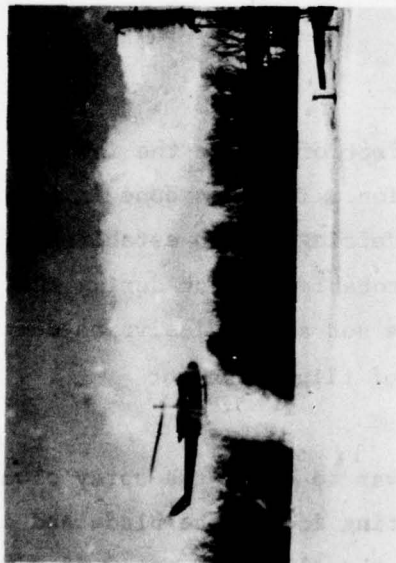
Figure 6. Different Views of the Test Aircraft Operating in the NRC Spray Rig

shield material was considerably reduced but not completely eliminated by the smoother joint of the new blades. It was apparent that any surface discontinuity can impair blade deicing to some degree and therefore should be avoided. For example, on occasions where a marginal heater-on time was used, ice would be retained on the blade which had the temperature sensors and strain gages installed whereas the other blade would be perfectly clean.

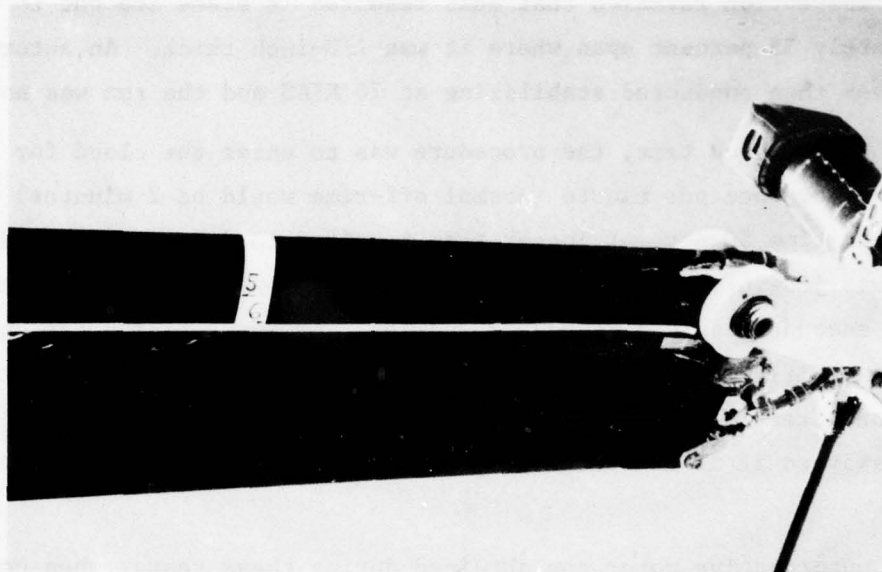
FLT 155 B

Figure 7. Satisfactory Main Rotor Blade Deicing Results, Zone 6 and Inboard Zone 5 on Spray Rig Test 5 ( $-7^{\circ}\text{C}$ ,  $0.65 \text{ g/m}^3$ , 30-Minute Spray Rig Run)

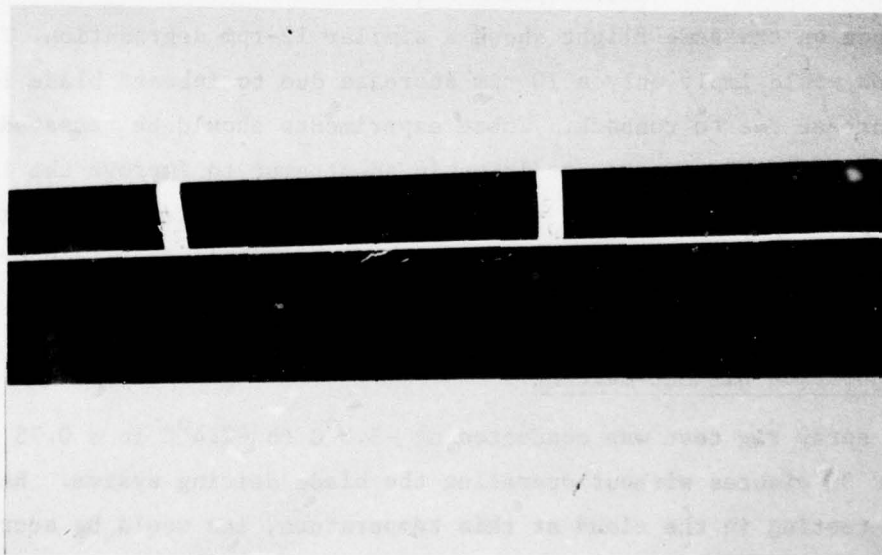
FLT 155 A

There was still repeated evidence of runback from the inboard heated area (zones 4, 5, and 6) even on the short heater-on time runs. The magnitude of the runback is not considered to be particularly severe since it appears that the number of deicing cycles, and therefore the amount of runback, that will occur on a typical natural icing flight will probably not be significantly different than viewed in the spray rig testing. Runback does imply an imperfect and undesirable blade deicing characteristic, however. The analysis of the blade surface temperature data obtained this year, as discussed in Section 4.11, indicates that the runback probably cannot be entirely eliminated because of the difference in erosion shield material covering zone 5, which is heated at a uniform power density, as described previously. Figures 7 and 8 show the excellent deicing results experienced this year, marred only by the runback from the inboard half of zone 5.

Figure 8. Satisfactory Zone 6, 5, and Inboard 4 Deicing Results Showing Only Slight Runback from Zone 5 Aluminum Area ( $-7^{\circ}\text{C}$ ,  $0.65 \text{ g/m}^3$ , 30-Minute Spray Rig Run)

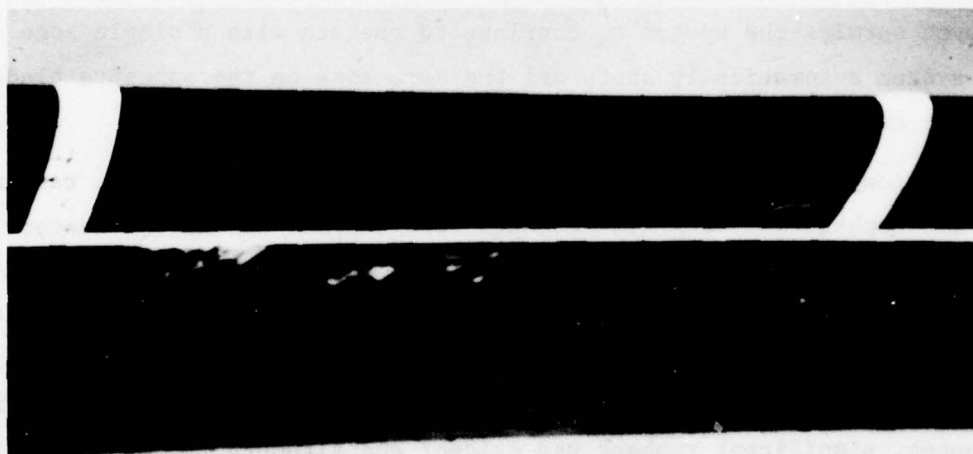
For the runback test, the procedure was to enter the cloud for 10 minutes and deice once per minute (normal off-time would be 2 minutes) using a heater-on time 50 percent longer than required to deice. The resulting runback was judged to be severe by the spray rig operator and as much as would be encountered (see Figures 9 and 10). An autorotation descent was made as expeditiously as possible following the ice accretion. Post-flight inspection after the descent showed that all of the runback ice had sublimated away so it is not known exactly what the condition was during the descent.

Figure 10. Induced Runback on Lower Blade Surface Aft of Zone 5

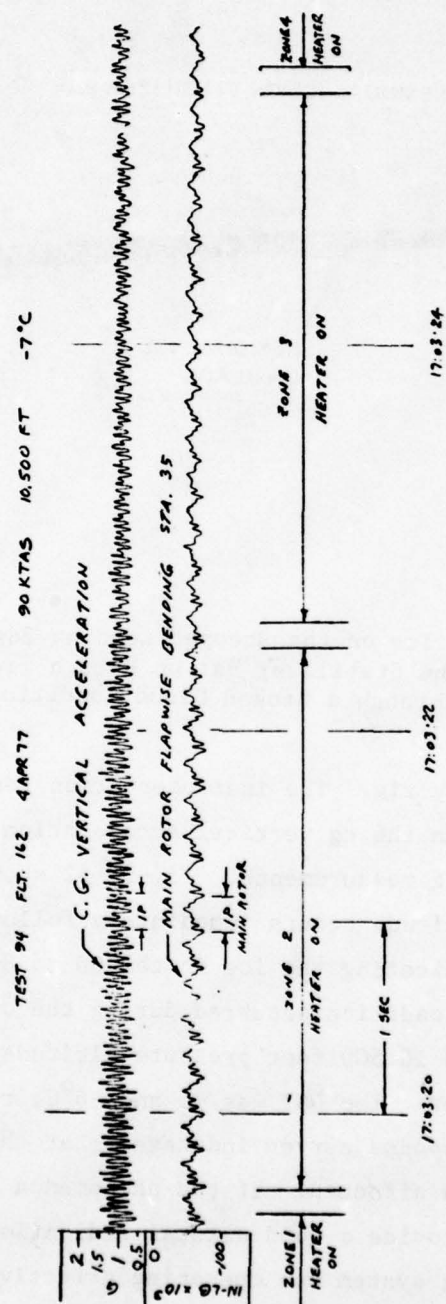
tanker or in the spray rig. The instrumentation test records showed the 6P vibration change in the cg vertical acceleration and in main rotor blade flapwise bending measurements. Figure 12 shows typical tracings. The reduction in amplitude occurs immediately following zone 2 heater-on time application, indicating the ice in the 60 to 80 percent span area was the cause. The condition occurred during the only two icing encounters at 9500 feet and 10,500 feet pressure altitude and was more pronounced at 10,500 feet. The OAT was  $-5$  and  $-6^{\circ}\text{C}$ , respectively. Examination of the blade response curves indicates that the third flapwise bending mode probably was affected. If the phenomenon were to occur all of the time, it would provide a good natural indication that the blades were icing and the deicing system was operating effectively. Unfortunately, it appears that it only occurs at the higher collective blade angle setting, as no amplitude change was noted or apparent on the test records at

Figure 12. 6-Per-Rev Vibration Change During Blade Deicing

7500 feet or below. It also points out that blade stresses can be affected by operation in icing conditions. The pilots reported an increase in workload was experienced flying under these increased vibration periods.

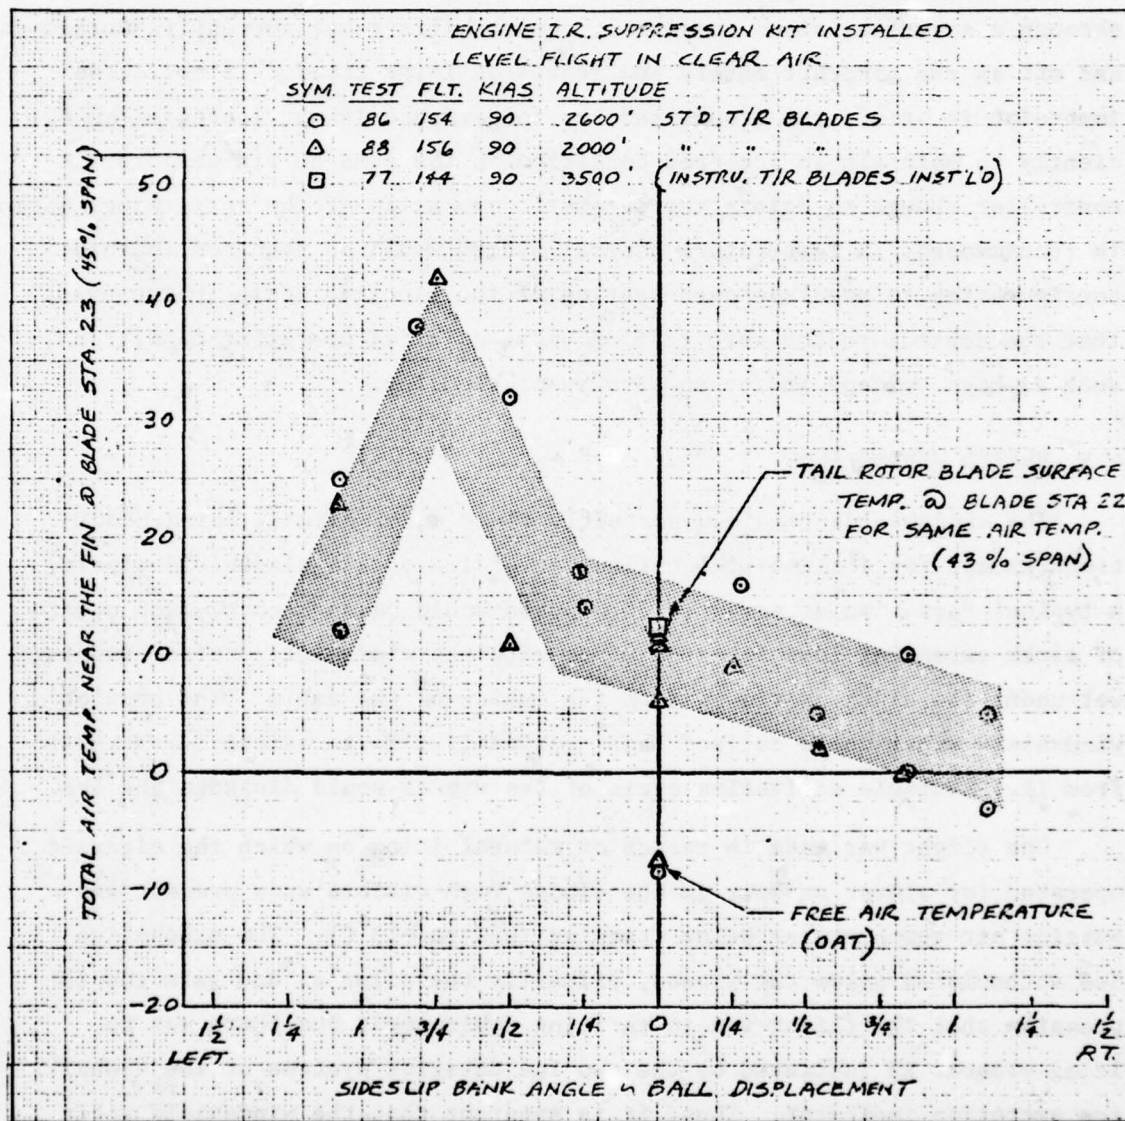
A survey of the variation of tail air temperature with sideslip angle as measured by the sensing probe is shown in Figure 14. Sideslip is presented in terms of ball displacement of the turn-and-slip indicator. A calibration check using a RH windshield-located yaw string indicated that a one-quarter ball displacement was equivalent to 10 degrees of sideslip angle. This data shows good agreement between the measured air temperature and blade surface temperature which verifies accuracy and indicates that the air temperature at the tail rotor is approximately 20 degrees warmer than ambient in clear air due to exhaust heating. The abrupt decrease in indicated temperature to the left probably indicates that the

Figure 14. Increased Air Temperature at the Tail Rotor Due to Engine Exhaust Heating

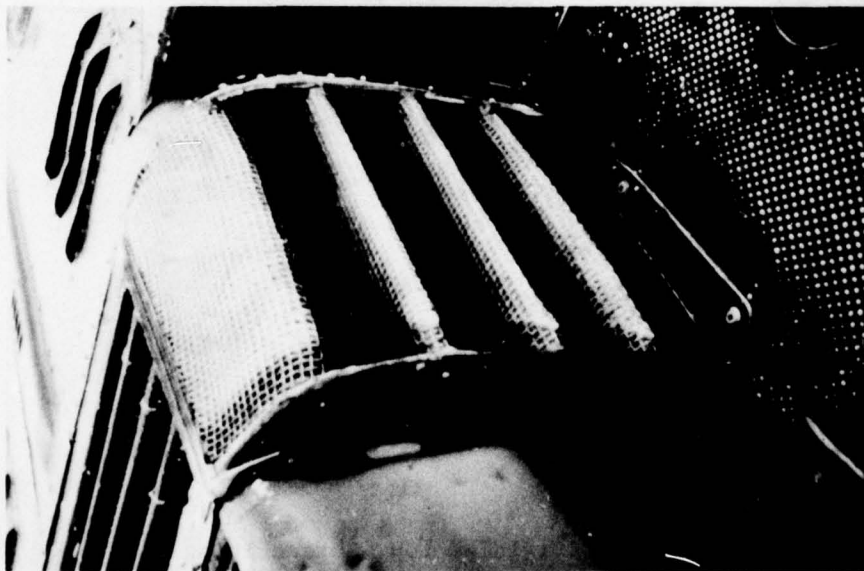
Flt. 155

C  
Close-Up Of Engine Air Inlet  
L.H. Screen Icing, 30 Minutes  
in Spray Rig At  $-7.3^{\circ}\text{C}$ ,  
 $0.65 \text{ g/m}^3$  (Measured  $\Delta P$   
Change = 1 inch  $\text{H}_2\text{O}$ )

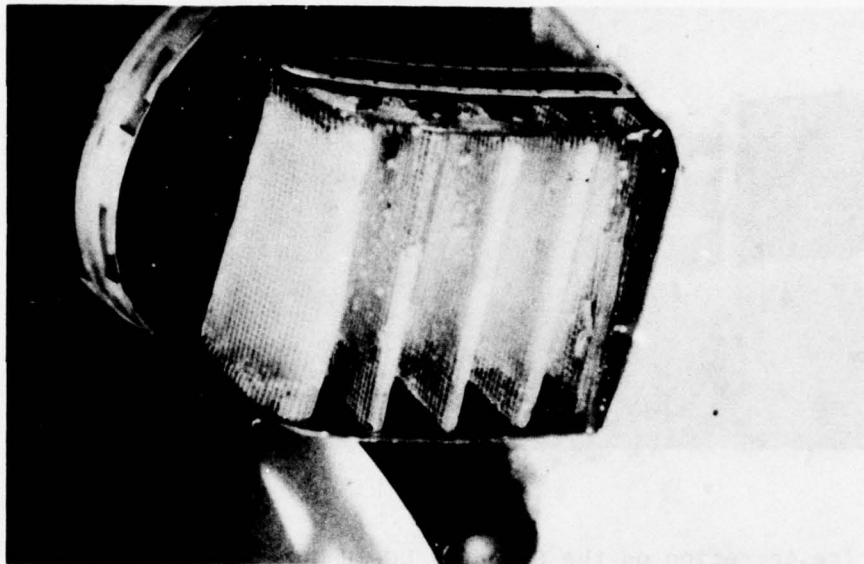
Flt. 80

291  
Close-Up Of Engine Air Inlet  
Screen Icing After 2.5 Minutes  
in Spray Rig at  $-3.5^{\circ}\text{C}$ ,  
 $0.80 \text{ g/m}^3$  (Measured  $\Delta P$   
Change = 0)

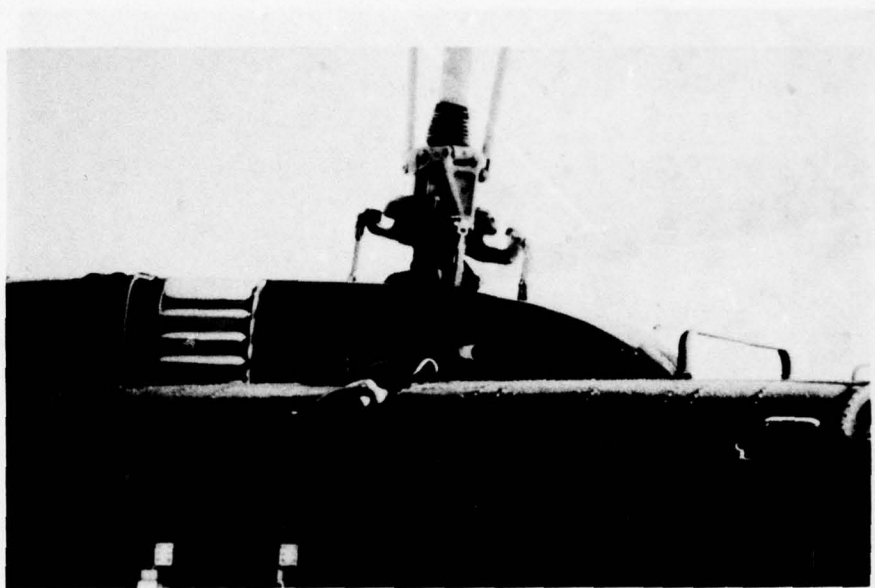
Flt. 72

Figure 42. Engine Air Inlet L.H. Screen Icing, 30 Minutes in Spray Rig at  $-6.8^{\circ}\text{C}$ ,  $0.70 \text{ g/m}^3$  (Measured  $\Delta P$  Change = 2 Inches  $\text{H}_2\text{O}$ )

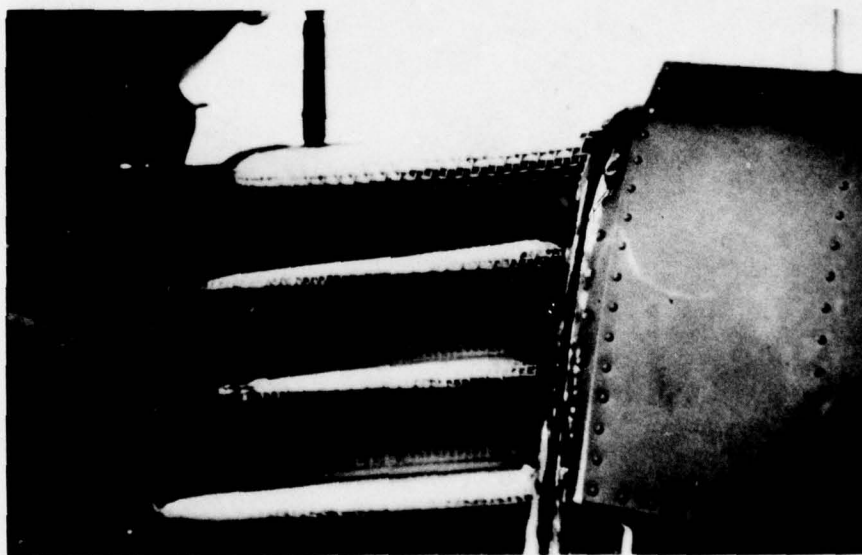
Flt. 72

Figure 43. Close-Up of Engine Air Inlet L.H. Screen Icing After 30 Minutes in Spray Rig at  $-6.8^{\circ}\text{C}$ ,  $0.70 \text{ g/m}^3$  (Measured  $\Delta P$  Change = 2 Inches  $\text{H}_2\text{O}$ )

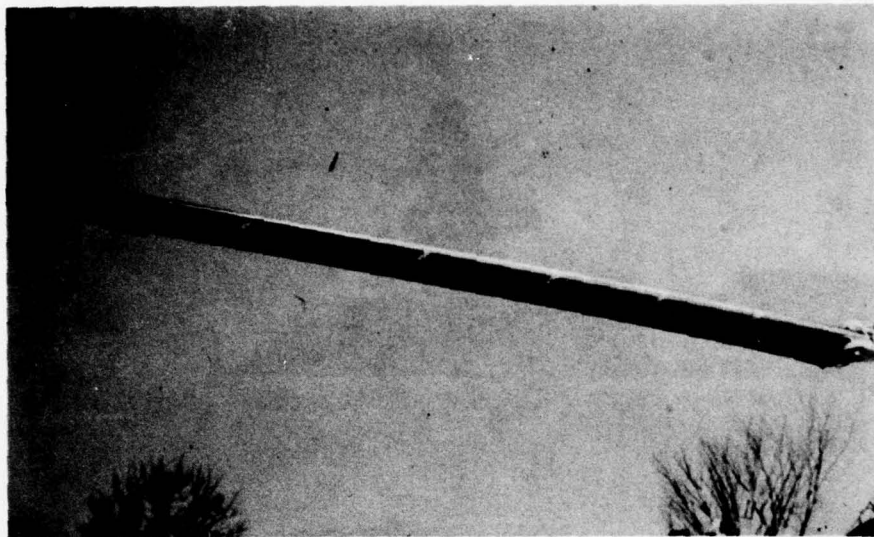
Flt. 81

Figure 44. Typical Ice Accretion on Main Rotor Blade Illustrating Maximum Ice Thickness Near Midspan (Spray Rig,  $-20^{\circ}\text{C}$ ,  $0.3 \text{ g/m}^3$ )

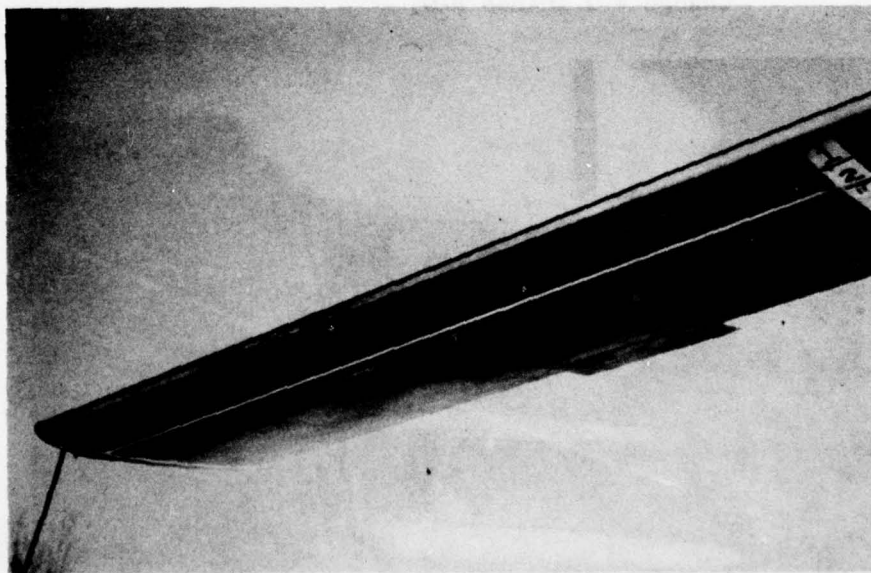
Flt. 81

Figure 45. Close-Up of Ice Accretion on Main Rotor Blade Zone 1 (Spray Rig  $-20^{\circ}\text{C}$ ,  $0.3 \text{ g/m}^3$ )

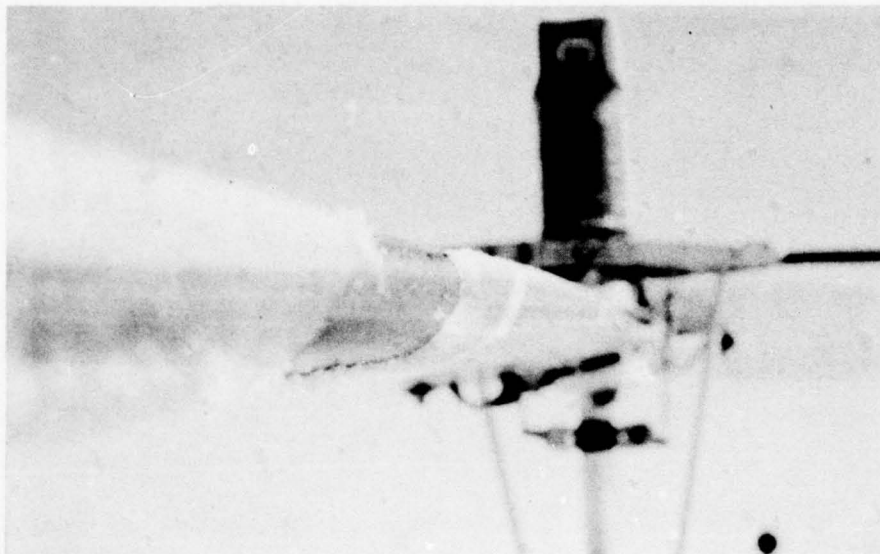
Flt. 89

Figure 46. Close-Up of Leading Edge Ice Accretion at Midspan After Ice Thickness Determination Had Been Made (Spray Rig, 1/4-Inch,  $-11^{\circ}\text{C}$ ,  $0.55 \text{ g/m}^3$ )

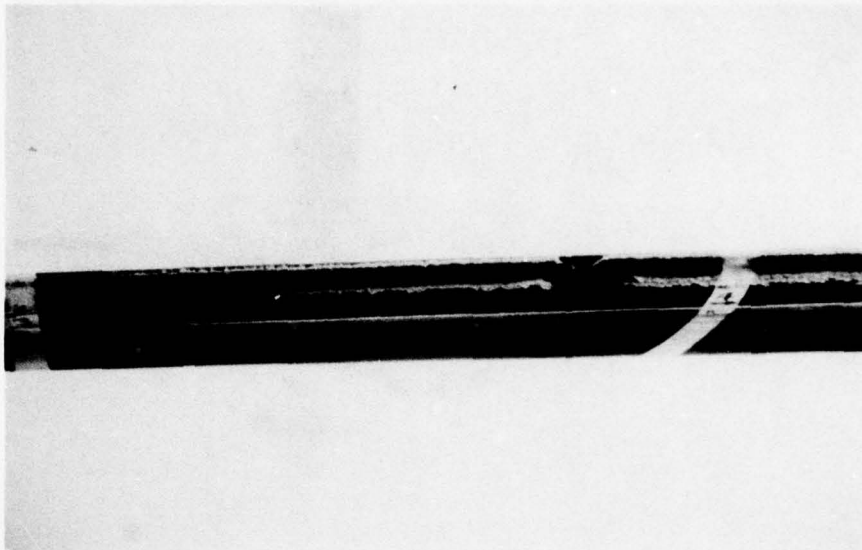
Flt. 86

Figure 48. 1/2-Inch Thickness of Main Rotor Blade Ice Accretion at Zone 3 ( $-12.2^{\circ}\text{C}$ ,  $0.3 \text{ g/m}^3$ , 3-1/2 Minutes in Spray Rig Cloud)

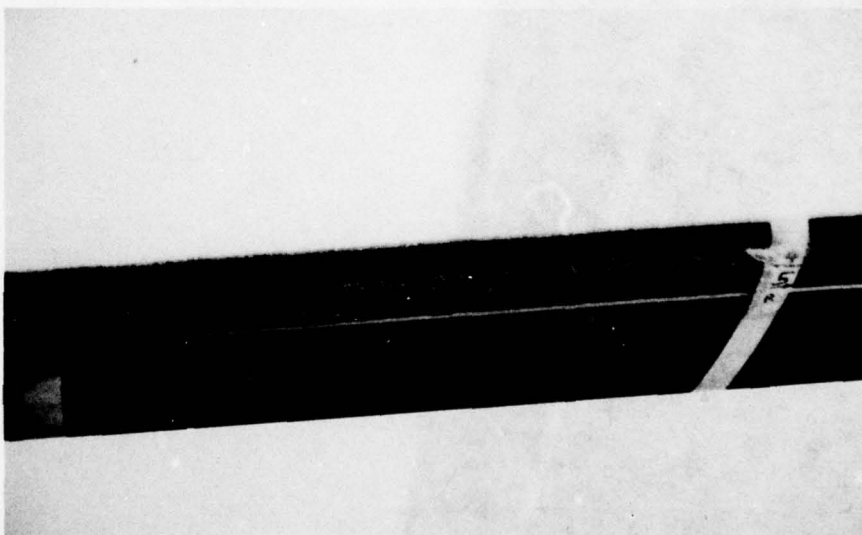
Flt. 86

Figure 49. Main Rotor Blade Ice Accretion at Zone 4 ( $-12.2^{\circ}\text{C}$ ,  $0.3 \text{ g/m}^3$ , 3-1/2 Minutes in Spray Rig Cloud)

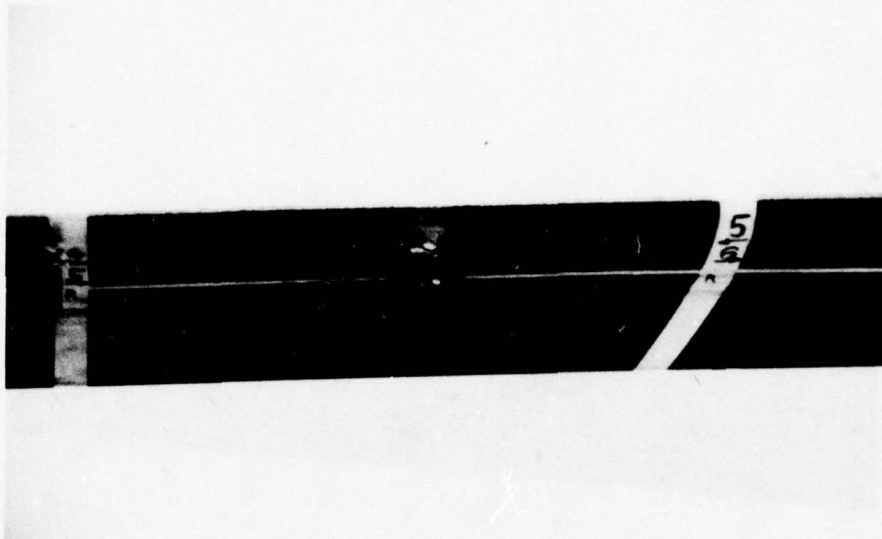
Flt. 86

Figure 50. Main Rotor Blade Ice Accretion at Zone 5  
( $-12.2^{\circ}\text{C}$ ,  $0.3 \text{ g/m}^3$ , 3-1/2 Minutes in Spray  
Rig Cloud)

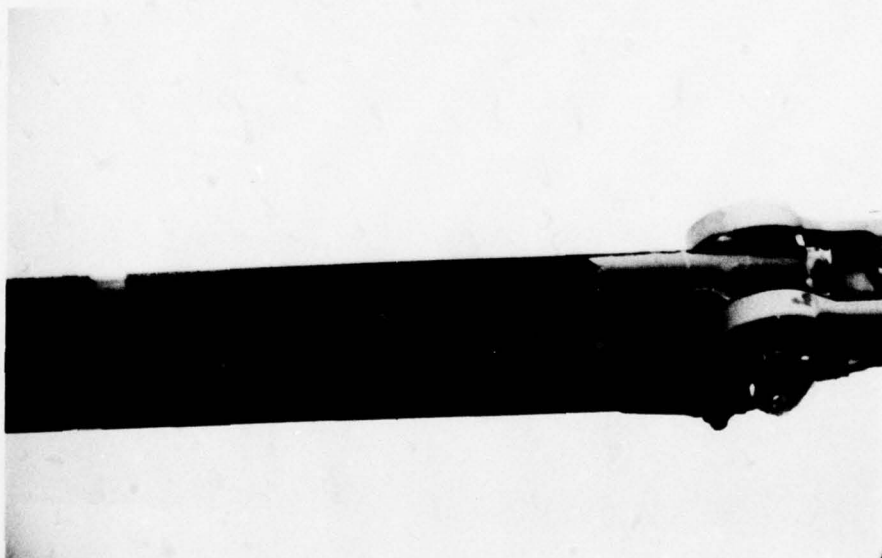
Flt. 86

Figure 51. Main Rotor Blade Ice Accretion at Zone 6  
( $-12.2^{\circ}\text{C}$ ,  $0.3 \text{ g/m}^3$ , 3-1/2 Minutes in Spray  
Rig Cloud)

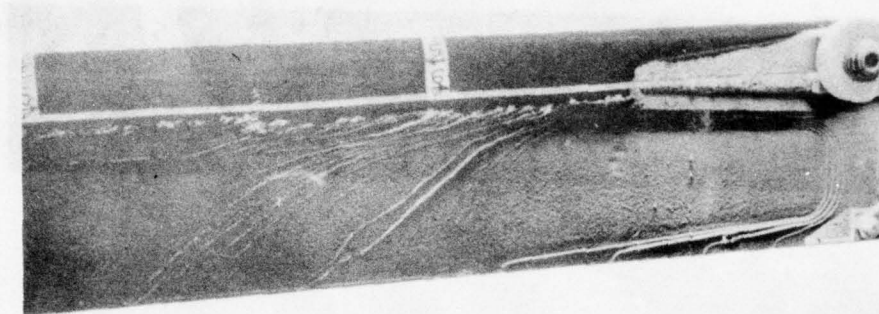
Flt. 86

Figure 33 shows the rate of temperature increase for each spanwise zone plotted versus design power density. It is apparent that the slope of heating rate versus power density does not pass through zero for the aluminum. This suggests that the actual power density for zone 6, at least along the leading edge in front of the root end fittings where the sensor is located, might be higher than the design 26 watts/in<sup>2</sup> - possibly as high as 33 watts/in<sup>2</sup>. This was not obvious from previous data due to the limited number of temperature sensors used in previous testing. This higher power density is probably the cause of the runback experienced from the zone 6 area (see Figures 52 and 53 in Section 8.1 of this report).

Figure 52. Main Rotor Blade Zones 5 and 6 Condition Following 30-Minute Spray Rig Run Deicing Each 3-1/2 Minutes for 9 Deice Cycles ( $-12^{\circ}\text{C}$  to  $-8^{\circ}\text{C}$ ,  $0.3 \text{ g/m}^3$ , Snow Falling During Test)

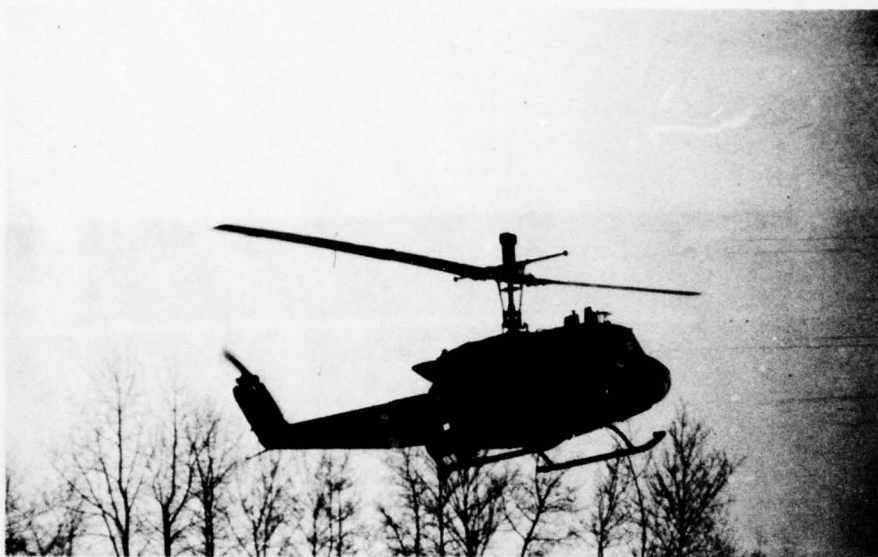
Flt. 87

Figure 54. Test Aircraft During  $-11^{\circ}\text{C}$ ,  $0.5 \text{ g/m}^3$  Spray Rig Run in Light Freezing Rain

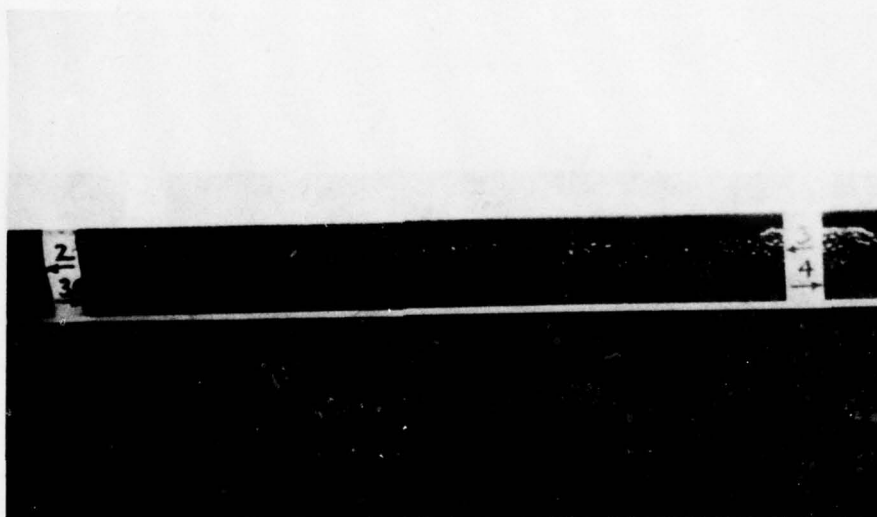
Flt. 87

Figure 55. Zone 3 Incomplete Deice Due to Insufficient Heater-On Time ( $-11^{\circ}\text{C}$ ,  $0.5 \text{ g/m}^3$ )

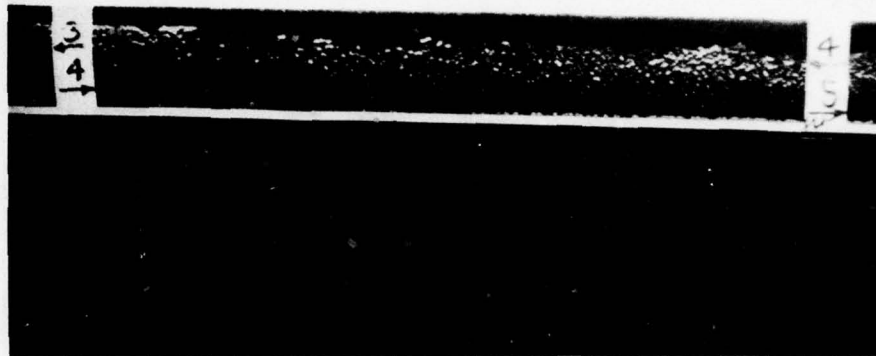
Flt. 87

Figure 56. Zone 4 Incomplete Deice Due to Insufficient Heater-On Time ( $-11^{\circ}\text{C}$ ,  $0.5 \text{ g/m}^3$ )

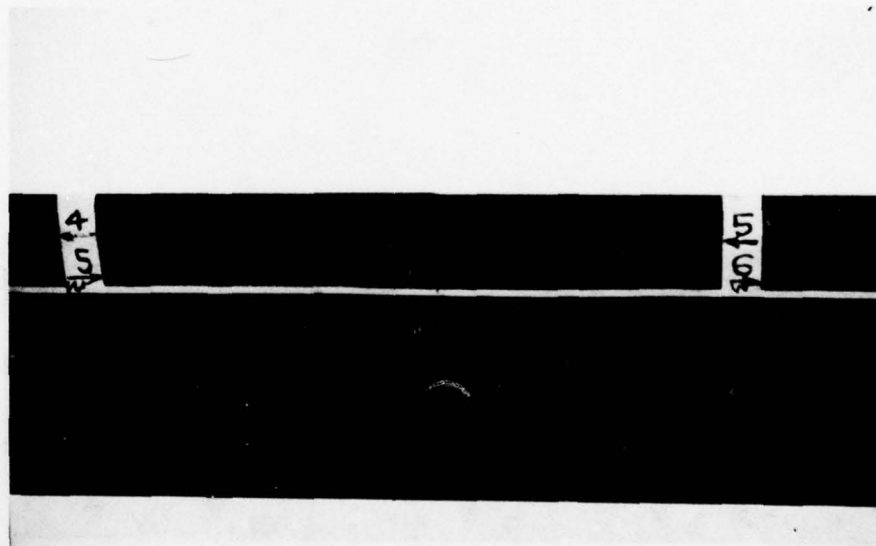
Flt. 87

Figure 57. Zone 5 Incomplete Deice Due to Insufficient Heater-On Time ( $-11^{\circ}\text{C}$ ,  $0.5 \text{ g/m}^3$ )

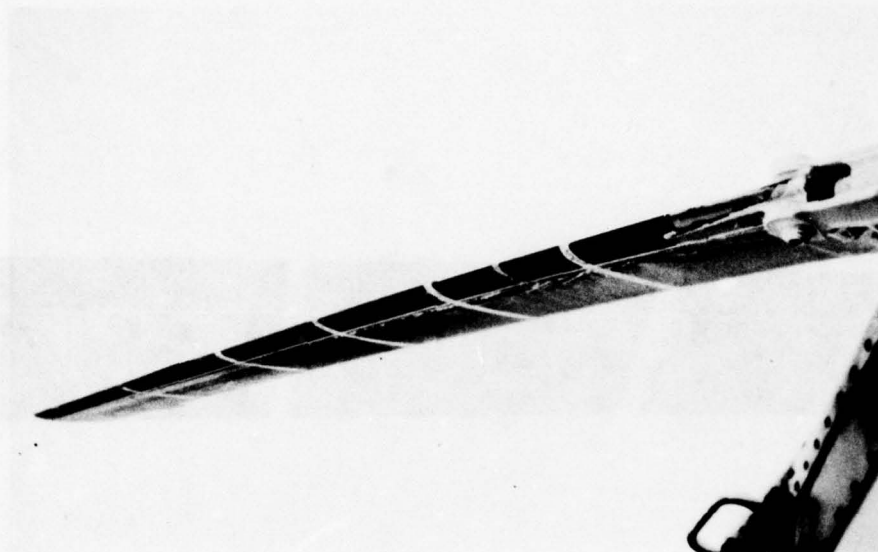
Flt. 87

Figure 58. Overall Blade Deicing Results Following 30-Minute Spray Rig Run ( $-11^{\circ}\text{C}$ ,  $0.5 \text{ g/m}^3$ ) in Light Freezing Rain

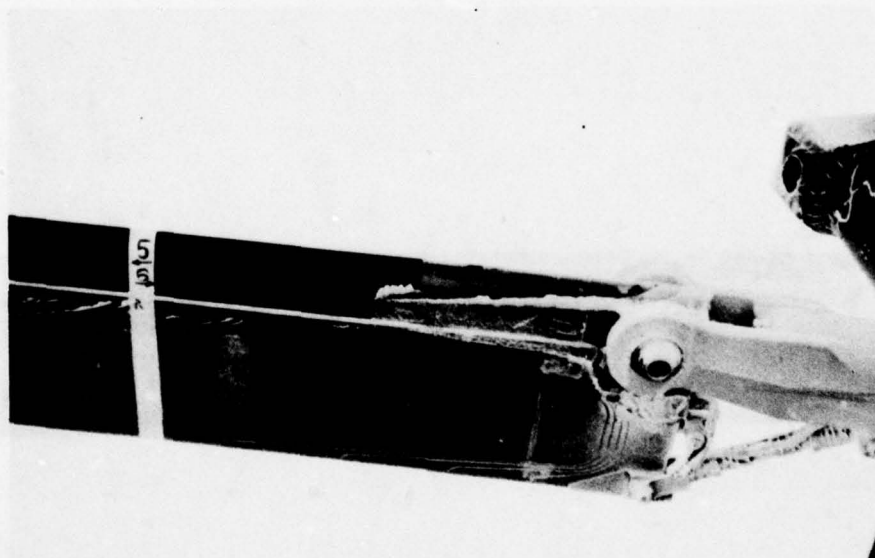
Flt. 87

Figure 59. Zone 6 Deicing Results Following 30-Minute Spray Rig Run ( $-11^{\circ}\text{C}$ ,  $0.5 \text{ g/m}^3$ ) in Light Freezing Rain

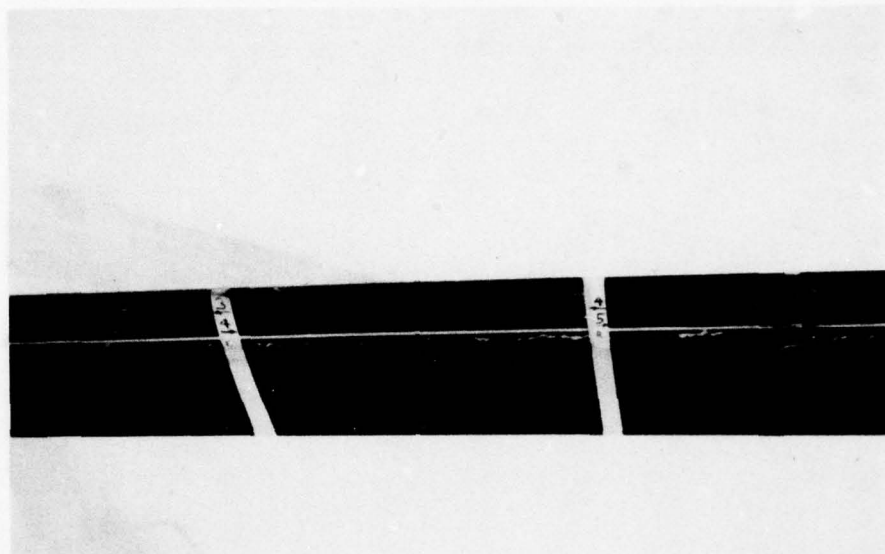
Flt. 87

Figure 60. Zone 5, 4, and 3 Deicing Results Following 30-Minute Spray Rig Run ( $-11^{\circ}\text{C}$ ,  $0.5 \text{ g/m}^3$ ) in Light Freezing Rain

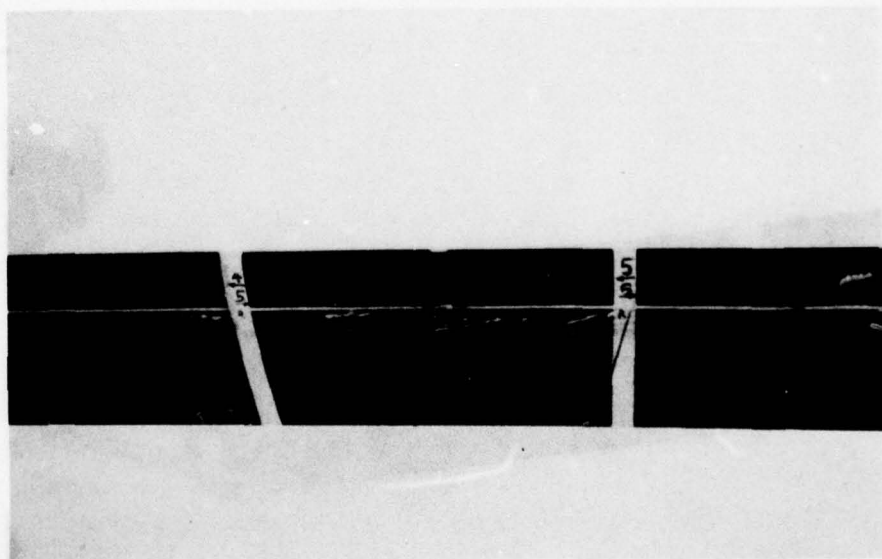
Flt. 87

Figure 61. Zone 6, 5, and 4 Deicing Results Following 30-Minute Spray Rig Run ( $-11^{\circ}\text{C}$ ,  $0.5 \text{ g/m}^3$ ) in Light Freezing Rain

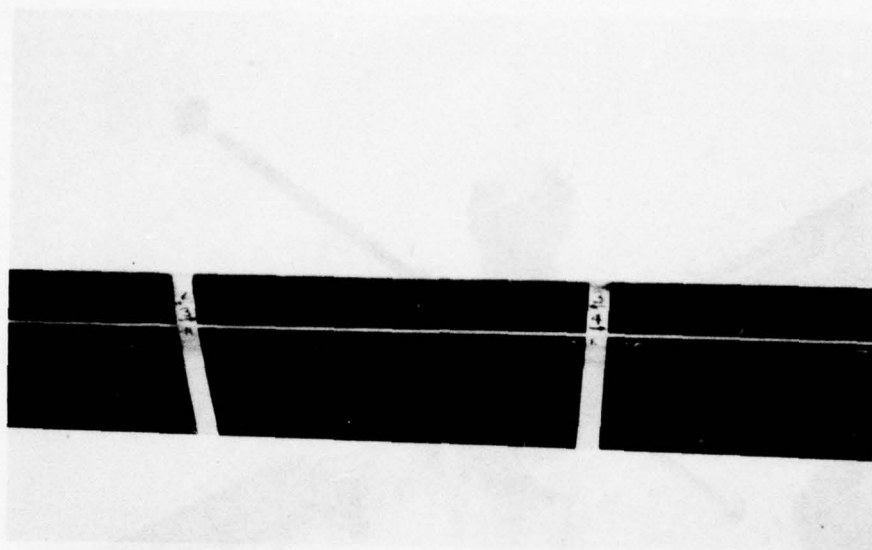
Flt. 87

Figure 62. Zone 3 Deicing Results Following  
30-Minute Spray Rig Run ( $-11^{\circ}\text{C}$ ,  
 $0.5 \text{ g/m}^3$ ) in Light Freezing Rain

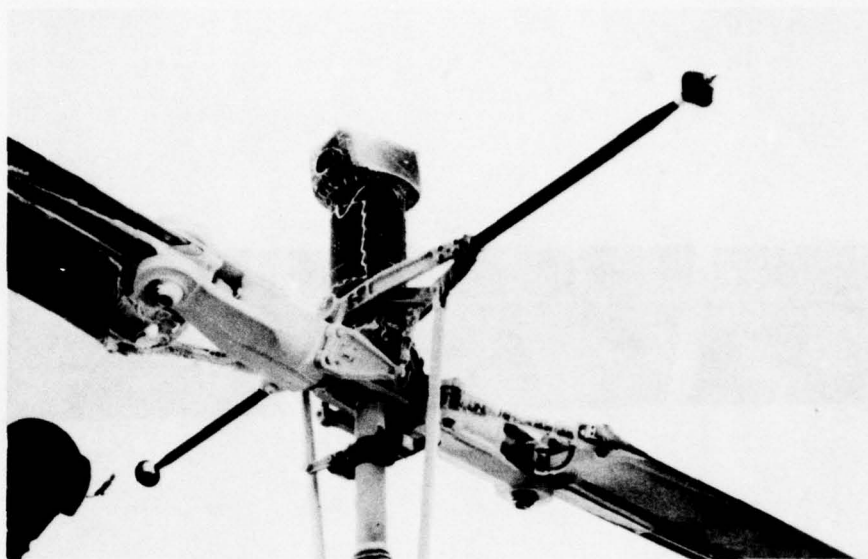
Figure 64. Rotor Hub Area Following 30-Minute Spray Rig Run ( $-11^{\circ}\text{C}$ ,  $0.5 \text{ g/m}^3$ ) in Light Freezing Rain

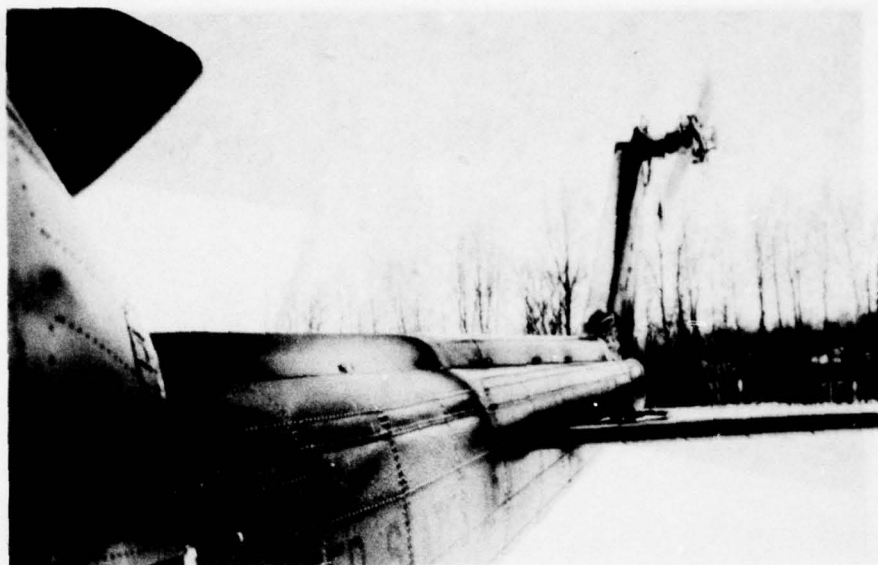
Figure 66. Freezing Rain on L.H. Side of Aft Fuselage After 30-Minute Spray Rig Run - Note Engine Exhaust Heat Pattern on Fuselage ( $-11^{\circ}\text{C}$ ,  $0.5 \text{ g/m}^3$ )

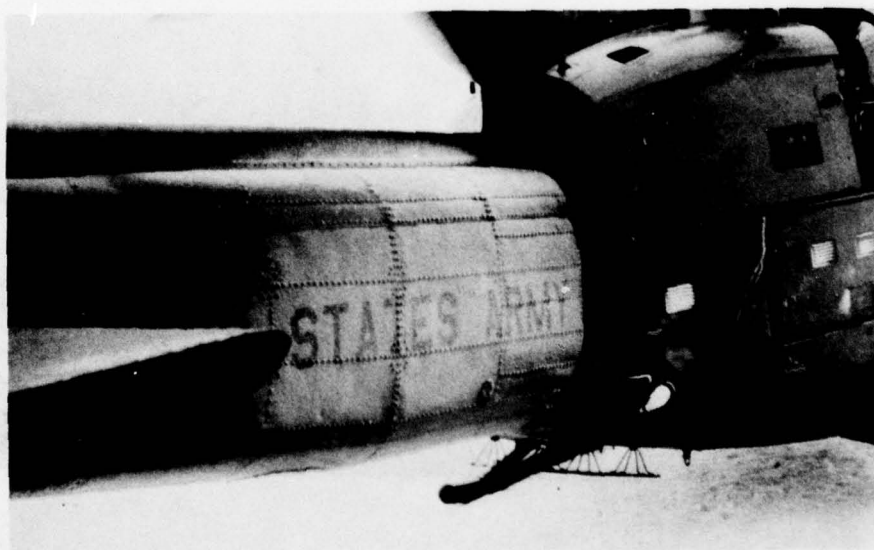
Figure 67. Freezing Rain on R.H. Side of Aft Fuselage After 30-Minute Spray Rig Run - Note Lack of Engine Exhaust Heat Pattern on Fuselage ( $-11^{\circ}\text{C}$ ,  $0.5 \text{ g/m}^3$ )

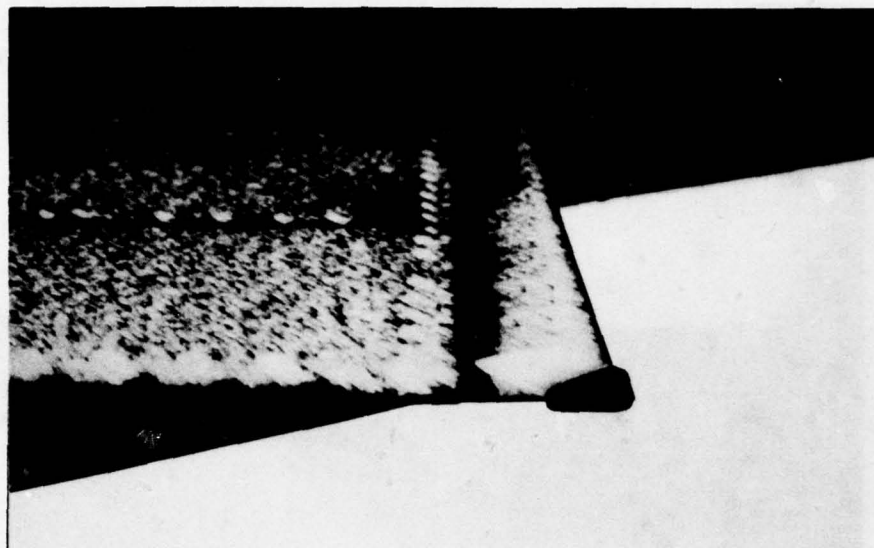
Figure 68. Close-Up of Ice Formation on L.H. Synchronizing Elevator After 30-Minute Run in Freezing Rain ( $-11^{\circ}\text{C}$ ,  $0.5 \text{ g/m}^3$ )

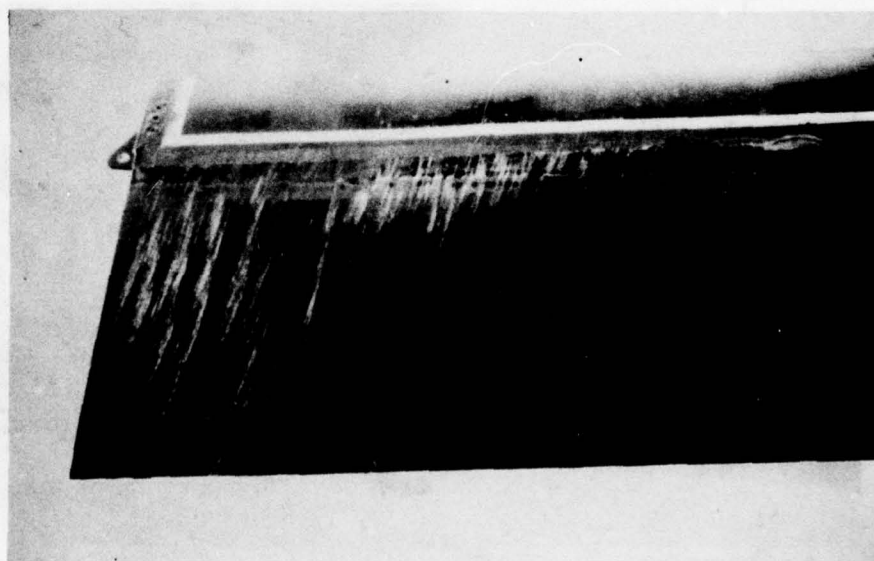
Figure 69. Intentionally Induced Runback on Lower Blade Surface from Zone 1 Resulting From Insufficient Ice Thickness (3 Cycles at  $1/2$  the Proper Off-Time) ( $-14.4^{\circ}\text{C}$ ,  $0.45 \text{ g/m}^3$ )

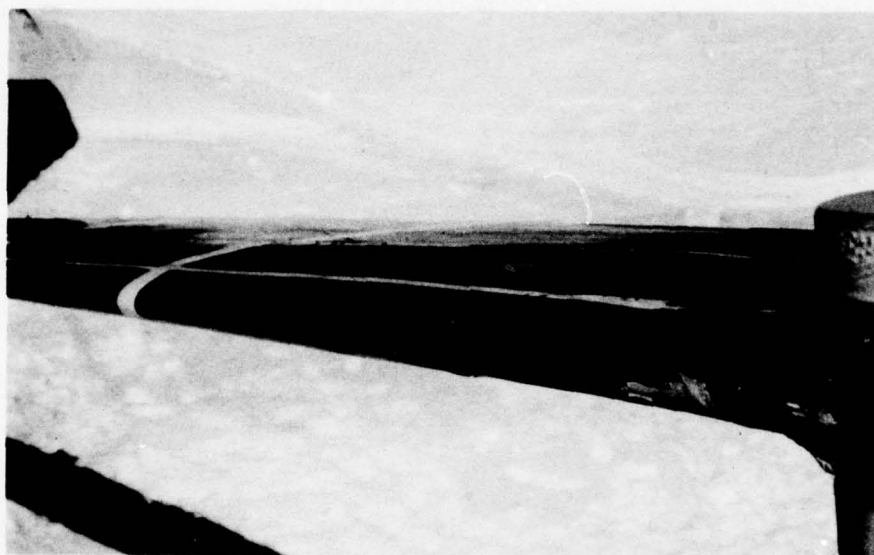
Figure 70. Main Blade Upper Inboard Surface Deicing Results  
Following 30-Minute Spray Rig Run - Red Blade  
( $-18^{\circ}\text{C}$ ,  $0.35 \text{ g/m}^3$ )

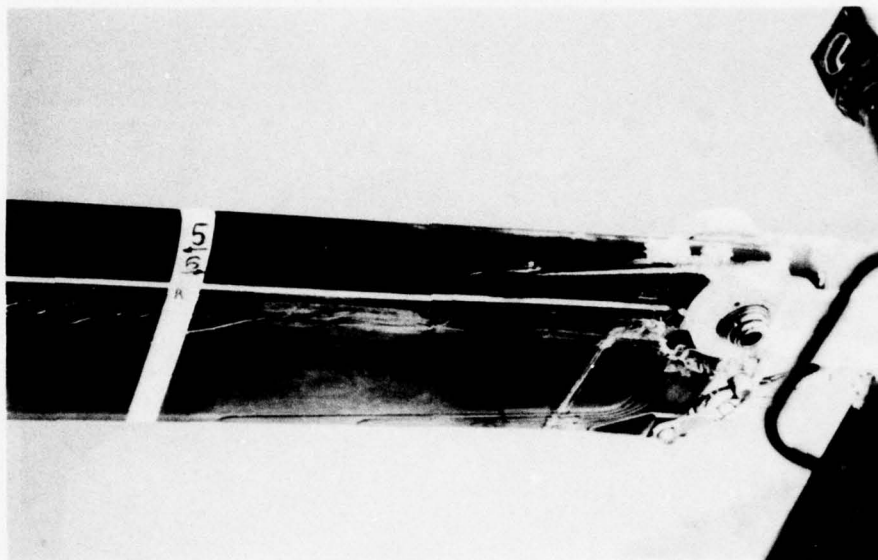
Figure 72. Lower Inboard Surface Deicing Results Following 30-Minute Spray Rig Run - Red Blade ( $-18^{\circ}\text{C}$ ,  $0.35 \text{ g/m}^3$ )

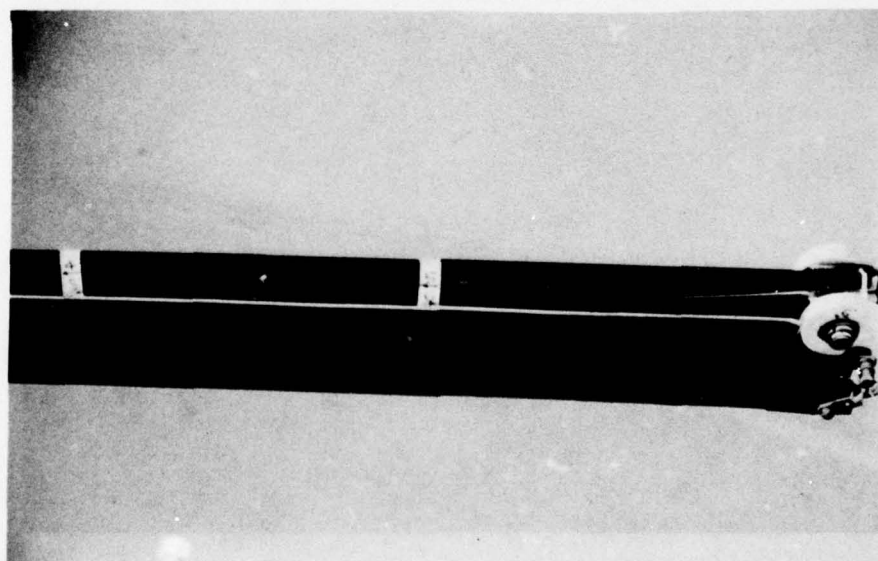
Figure 73. Lower Inboard Surface Deicing Results Following 30-Minute Spray Rig Run - White Blade ( $-18^{\circ}\text{C}$ ,  $0.35 \text{ g/m}^3$ )

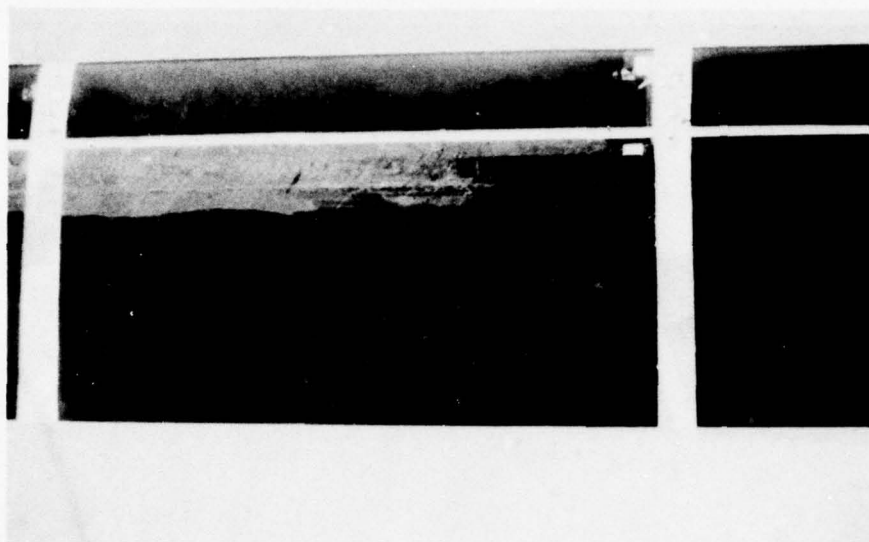
Figure 74. Lower Surface Zone 4 Deicing Results Following 30-Minute Spray Rig Run - Red Blade ( $-18^{\circ}\text{C}$ ,  $0.35 \text{ g/m}^3$ )

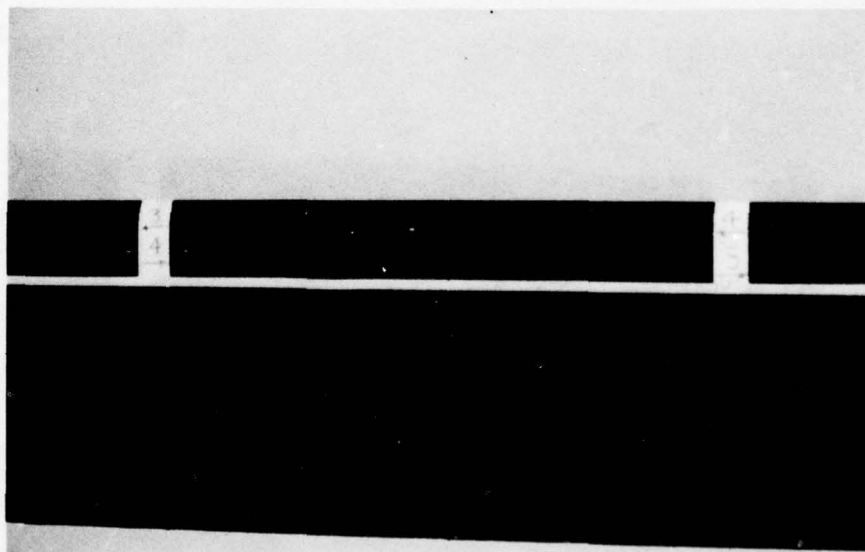
Figure 75. Lower Surface Zone 4 Deicing Results Following 30-Minute Spray Rig Run - White Blade ( $-18^{\circ}\text{C}$ ,  $0.35 \text{ g/m}^3$ )

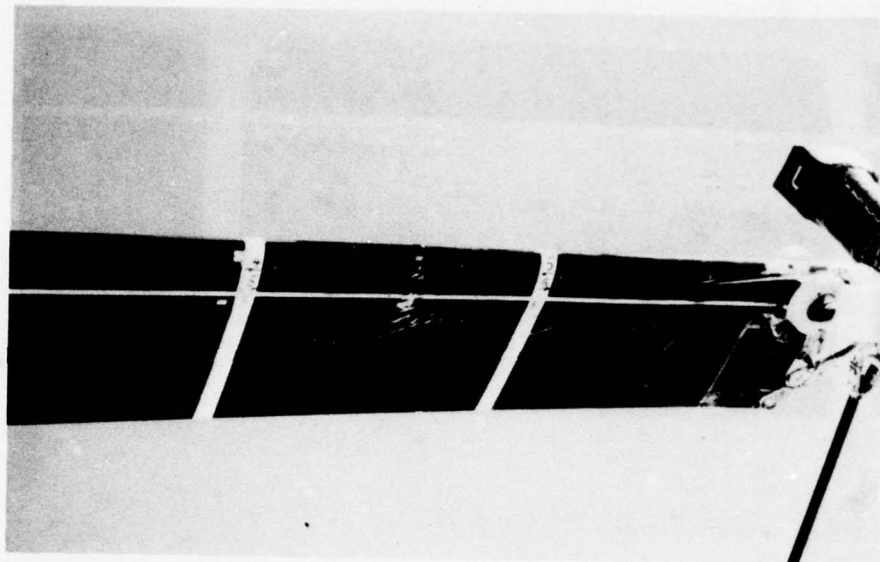
Figure 76. Lower Inboard Blade Surface Runback Condition Following 30-Minute Spray Rig Run - Red Blade ( $-18^{\circ}\text{C}$ ,  $0.35\text{ g/m}^3$ , 6 Deice Cycles)

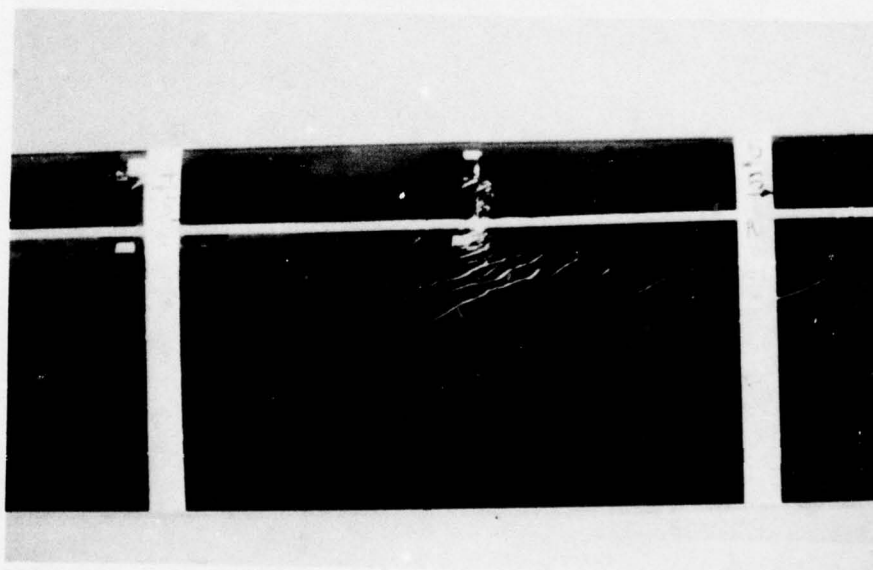
Figure 77. Close-Up of Runback from Inboard Half of Zone 5 Following 30-Minute Spray Rig Run - Lower Surface, Red Blade ( $-18^{\circ}\text{C}$ ,  $0.35\text{ g/m}^3$ , 6 Deice Cycles)
